# Earth leakage in the DL1 and DL21 system.

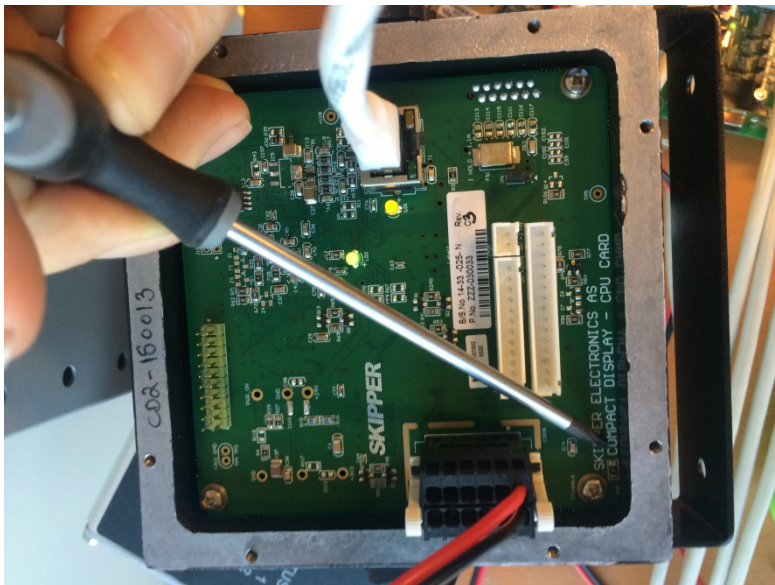
Due to a production error in these units a resistor R97 has been placed on the card that short circuits the power ground to the Earth/Housing. This is removed in later batches.

Replace the unit, or remove the resistor R97 by removing the back off the Display unit and removing the Resistor on the bottom left. This can be unsoldered, or cut away.
