Failure of STW value on DL850 270kHz

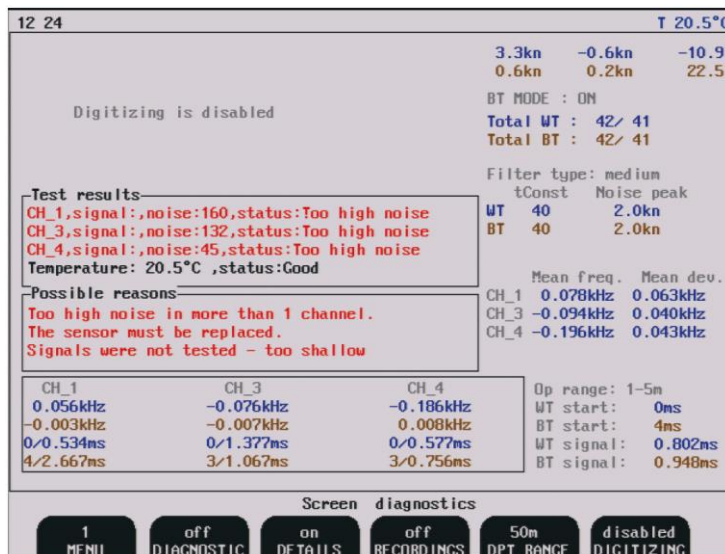
Effectuated sensors will have periods where a high frequency oscillation is present on one or more receiver channels. When this happens a signal of around 10MHz can be measured (with a scope) on the effected receiver channel on connector J503 in the transceiver cabinet DL850T27-SB.

- Install software 4.04.01 or later
- Run diagnostic test on screen diagnostics when the failure is occurring
- Check the test results for error 'Too high noise'

If 'Too high noise' on 2 or 3 channels, or if the noise moves from channel to channel -The sensor must be replaced with a sensor with SN >181132 (manufactured November 2018 or later)

If repeatable tests are showing only one channel failing it is possible to temporarily use only 2 channels for speed log measurements. See Appendix 5 “Beam filter” in the operation manual for sw ver 4.04.01 or higher for procedure.
