<b>SKIPPER DATA BULLETIN</b>		<i>Number</i>	SDB_DL850_14
<i>For System</i>	<i>Service</i>	<i>Date</i>	25.9.09
<i>Serial from / to</i>	< DT XX090199	<i>Author</i>	PC
<h1>Upgrading to SW 4.02.03 with New PLD (LG-T001)</h1>

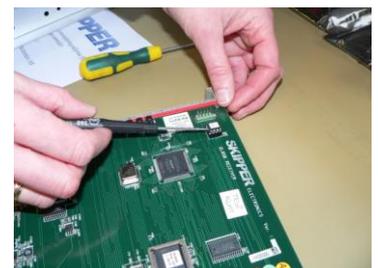
1. Open the transceiver cabinet and turn off the power.
2. Remove the Receiver card (furthest to left with 3 LEDs)
3. Remove the existing PLD and insert the new, making sure pin 1 is in correct place (the 'notch' should face up)
4. Reseat and fasten the card. Turn on power.

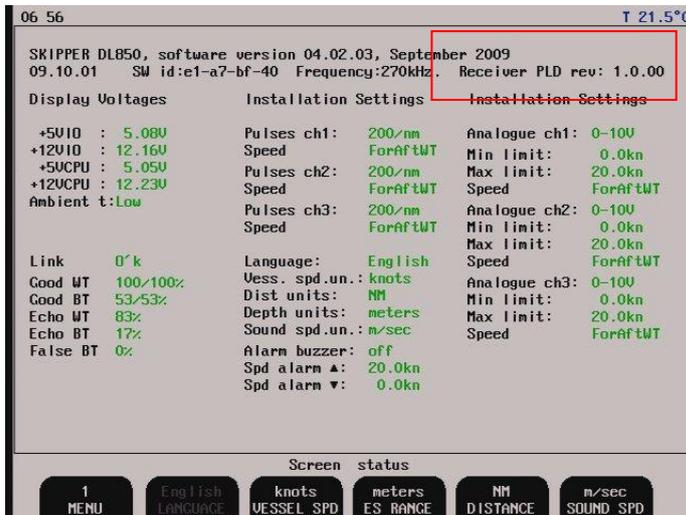
Status screen in new software with new PLD chip IC801 installed

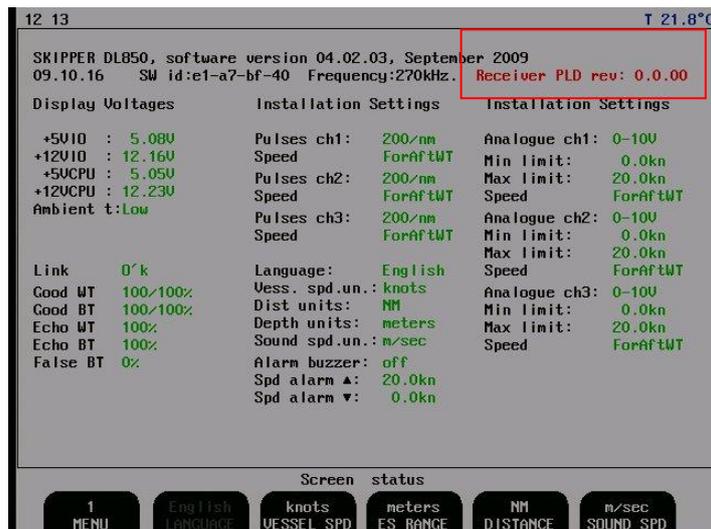
Status screen in new software with old PLD version 0.0.0 installed

1.6 If this software version is installed within the Doppler system with the old version of the receiver PLD, its revision number will be indicated by the red color.
