Service data bulletin

Instrument: GDS101

Date: 23.03.2006

SUBJECT: Plugs on transceiver board have no guides.
This makes it possible to insert cables into board in wrong direction.

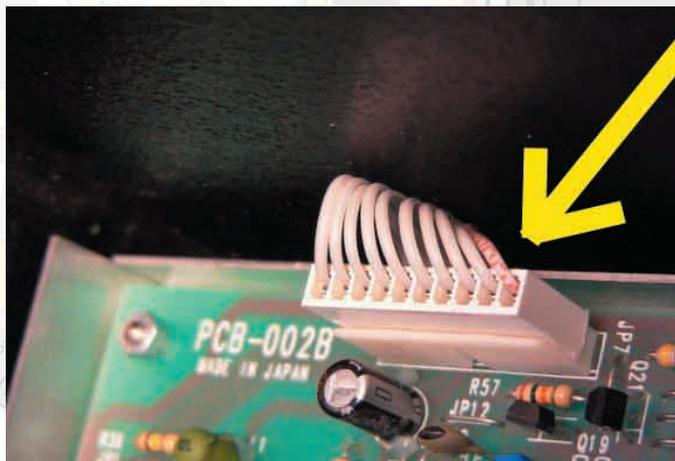
CN1: Red lead right

WHAT TO DO: When replacing transceiver board or cables to transceiver board you have to be careful
insert the cables the correct direction.

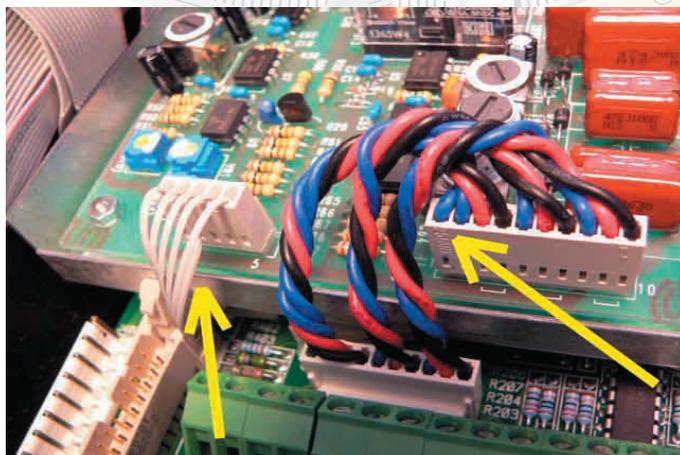
CN2: 2 blue leads left

CN3: Cutted lead right
