## Service data bulletin

Instrument: GDS101  
SDBGDS101\_33 Burned resistors on terminal PCB

Date: 09.10.2014  
Created by: Geir Theodorsen

### BURNED RESISTERS ON TERMINAL PCB

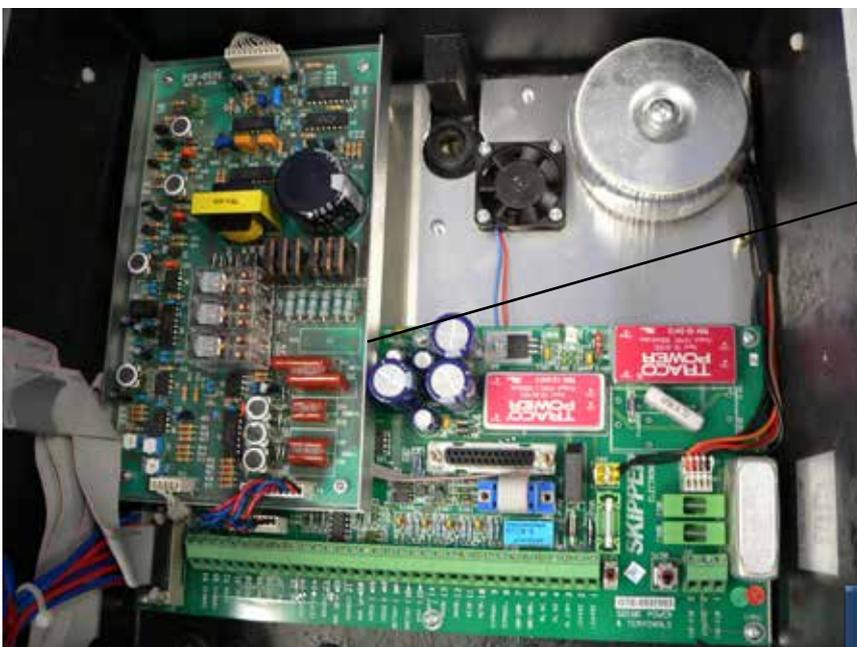
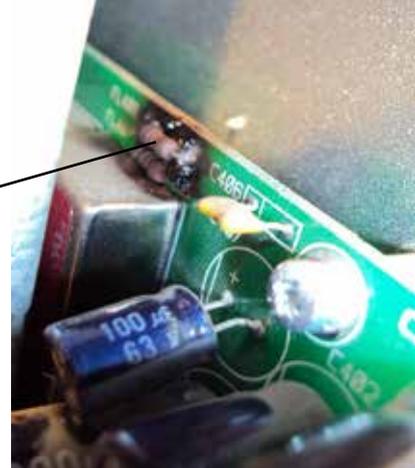
Problem: "Lost bottom"

Fault description: FL406 and FL407 are 10 Ohm resistors on "Terminal PCB". (See below pictures)  
They are installed in 48V power to transducer. Some of these resistors have become overheated after a few years of usage.

How to fix: A damaged (short circuit) transducer or heavy load on transducer may be the cause of damage.  
Set "FIX RANGE ON" in "Screen 9". This will inhibit the heavy load of looking for bottom outside the set "range" when vessel is sailing in open sea for days.

If PCB is burned then change complete PCB. Part number PT-G041 (GDS101 colour).  
If PCB is not damaged it should be possible to replace the resistors with locally purchased 10 Ohm 2 Watt resistors.

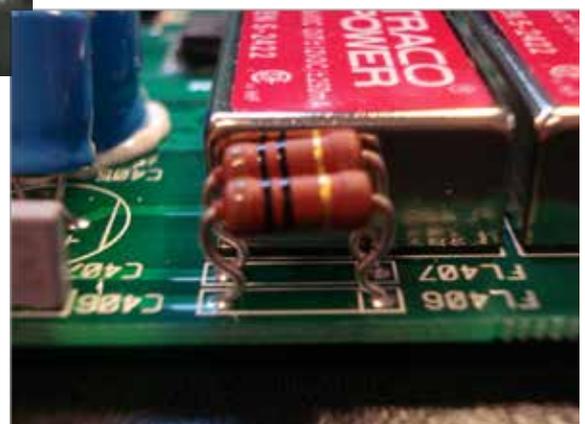
Example for correct mounting resistor with long leg for better cooling / air circulation
