EML224 Sensor Recovery

This document is to be used as a guideline to reprogram an EML224 sensor in cases where a firmware upgrade through the SKIPPER Service Software has failed or for some reasons has changed the output speed from default 4800kb/s to e.g. 115200kb/s.

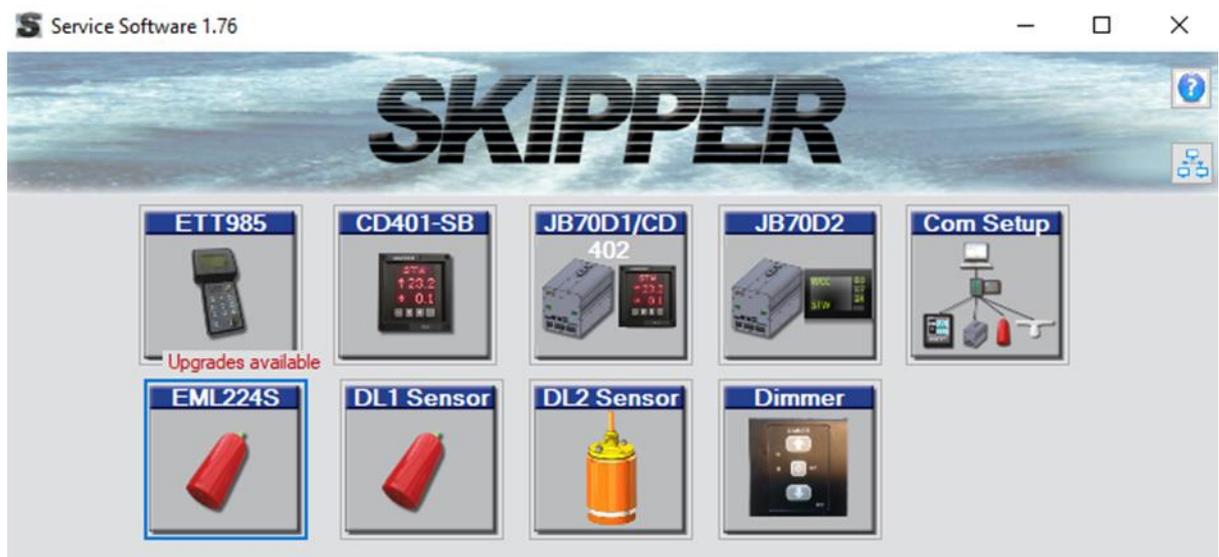
- 1) Leave the Sensor Power wires White (+) – Black/White (-) connected. Check the voltage reading and make sure it is between 18 and 32 Vdc.
- 2) Connect the NMEA Sensor In and Sensor Out to your NMEA adapter.
 - > Sensor: Black (+) – Yellow/Black (-) < Sensor: Orange (+) White/Orange (-)
- 3) Start the Skipper Service Software and select **Com Setup**.

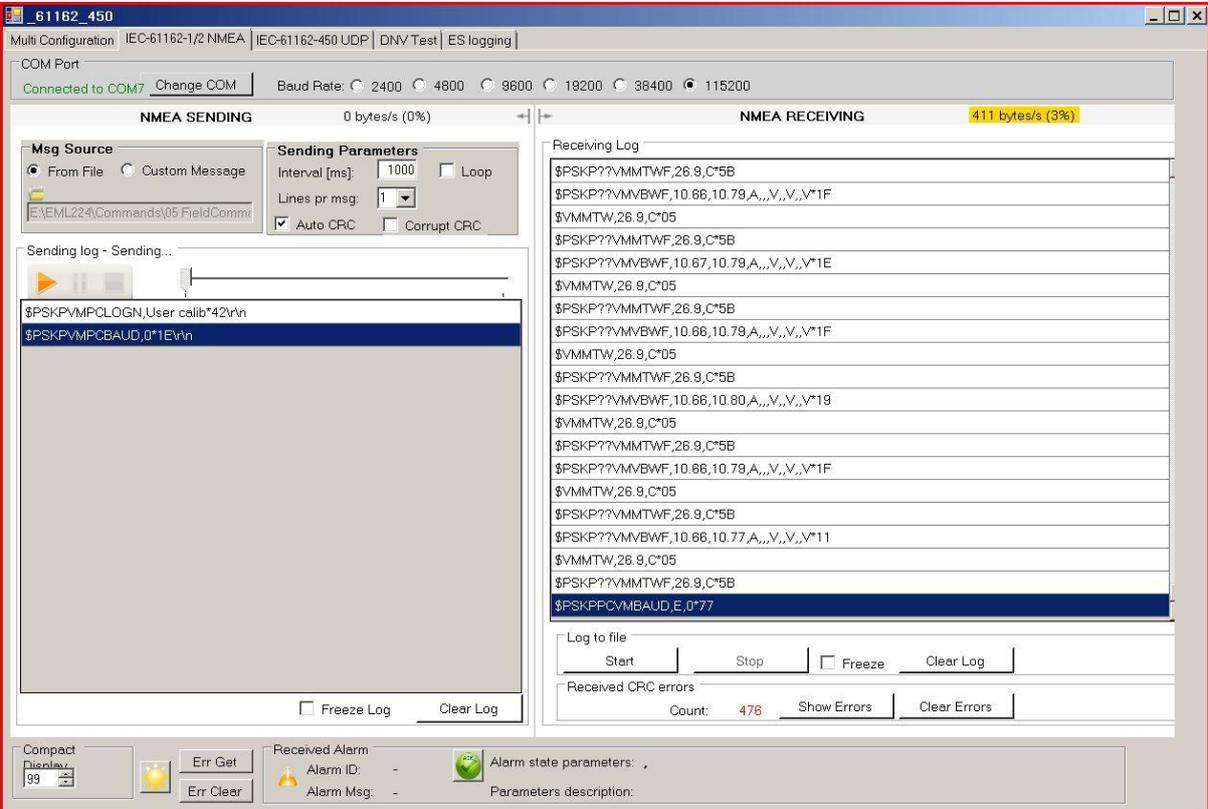
When the two sentences above have been written to sensor your ReceivingLog window should stop receiving messages if successful, this due to the Baud Rate change.

Please note that Login is required, else you will receive an Access Denied message.

Copy and paste above strings and send them one by one to sensor by pressing the **PLAY**

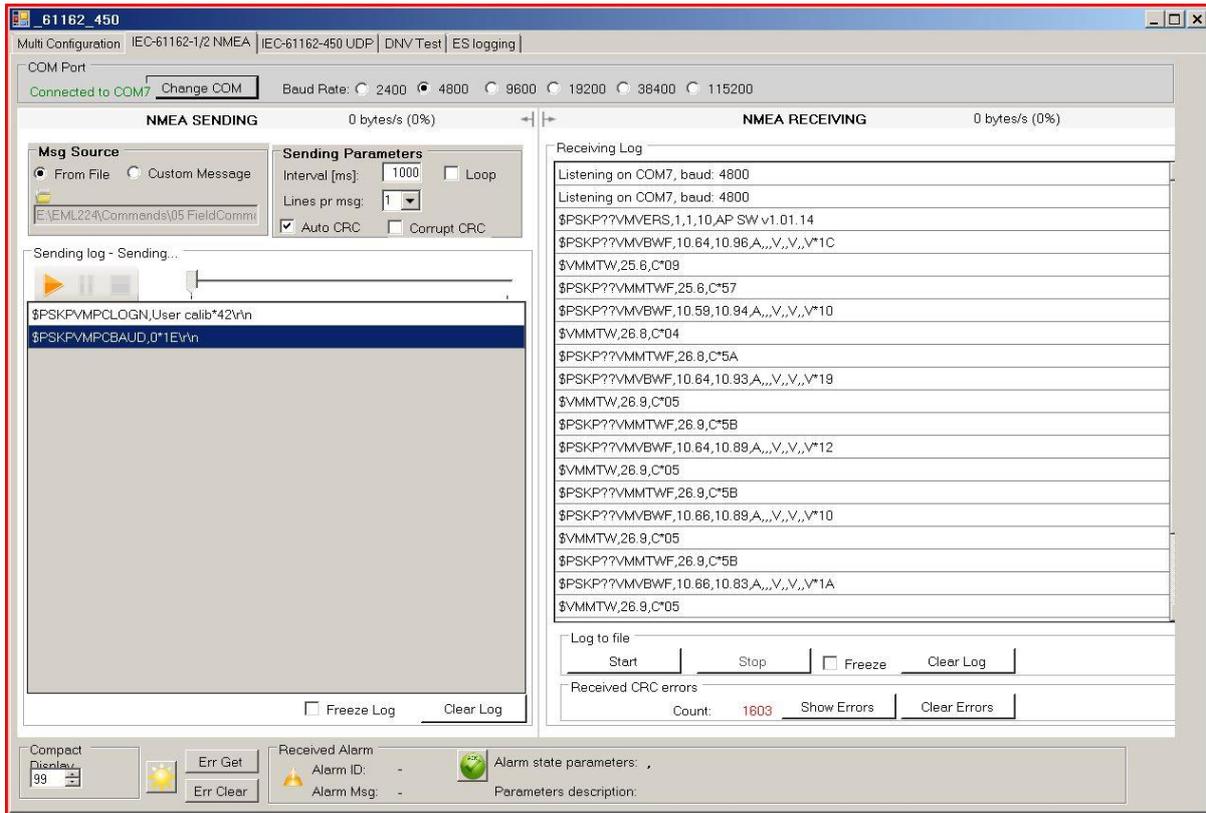
- 7) Cycle sensor power and change the Baud Rate back to 4800kb/s. Messages should now appear in the ReceivingLog window.
