SKIPPER DATA BULLETIN		<i>Number</i>	SDB_EML224_04
<i>For System</i>	EML224S	<i>Date</i>	09.09.09
<i>Serial from / to</i>	07000 - today	<i>Author</i>	PC
<h1>Procedure for cleaning/testing an EML sensor.</h1> <hr/>

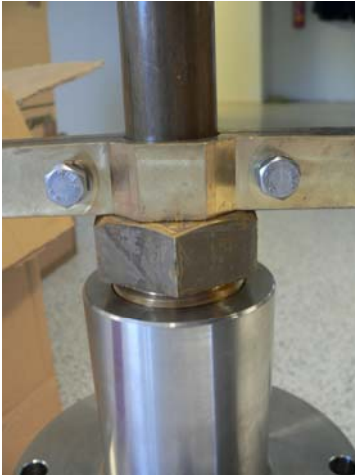
Growth/plating on the sensor.

- With time organic growth can occur on the pins, this results in higher resistivity and lower measured speed.
- A plating occurs on the centre pin of the sensor. This may be linked to an active ICCP antifouling system, or copper anodes.
- The Vessel has stood still for a period of time with no power (Power to the sensor reduces growth rate)

1. Mark the position of where the mounting pole exits through the gasket.

The symptoms above can be fixed by cleaning of the sensor. Mark the position of the pipe relative to the gatevalve to ensure the sensor is replaced correctly.

3. Carefully scrape away the growth until the shiny metal can be seen on all the pins, use the end of a flat screwdriver or similar.

4. Replace the sensor, ensure the sensor is all the way down, by realigning your mark from point 1, and that the flat edge of the pole is on the port side as in the manual.
5. Allow the sensor to acclimatize, this can take 3-6 hours depending on how much cleaning is performed, until the speed signal becomes stable.
6. If necessary, recalibrate the sensor both for heading offset and speed.
7. Check the calibration factors are less than 50%. Expected to be approx 30% i.e. 7 knots measured = 10 knots real speed
