## Service data bulletin

Instrument: GDS101

Date: 23.03.2006

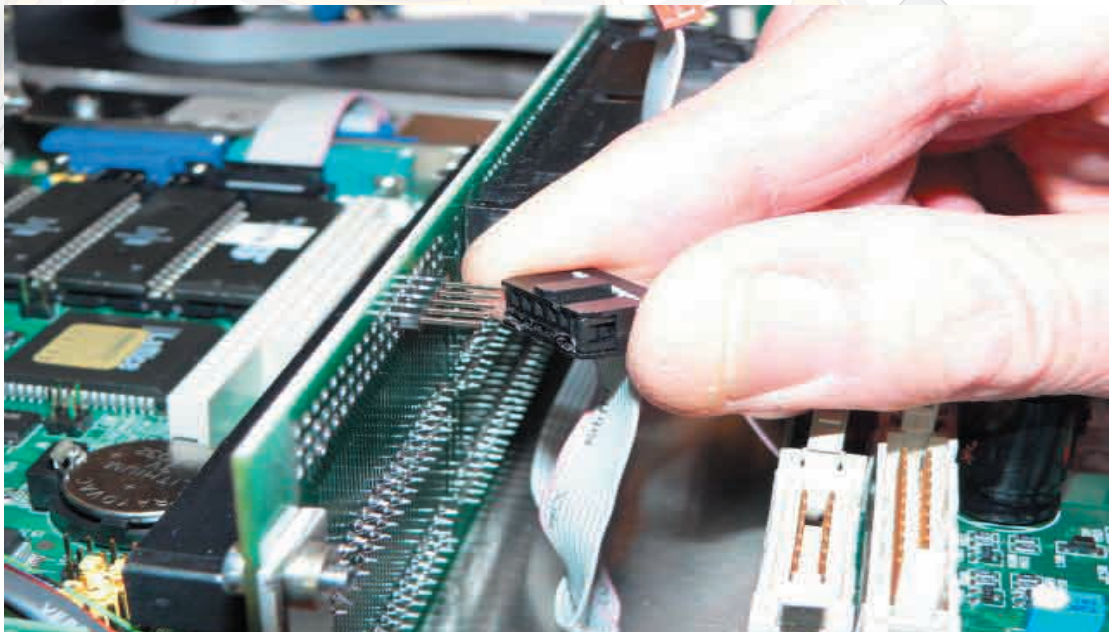
**SUBJECT:** Encoder cable (from I/O board to mother board) can be inserted into wrong position.  
(See picture)  
On newer GDS units the lower pins on encoder cable are blocked.  
This is not implemented on older models, thus there is a possibility to insert it wrong

**SYMPTOM:** Only access to page 1,2 and 3 (after service)

**WHAT TO DO:** On picture the lower pin row is blocked. The upper row is inserted.
