| SKIPPER DATA BULLETIN | | Number: | SDB_DL850_17 |
| DL850S-SB sensor wrong forward direction mark | | | |

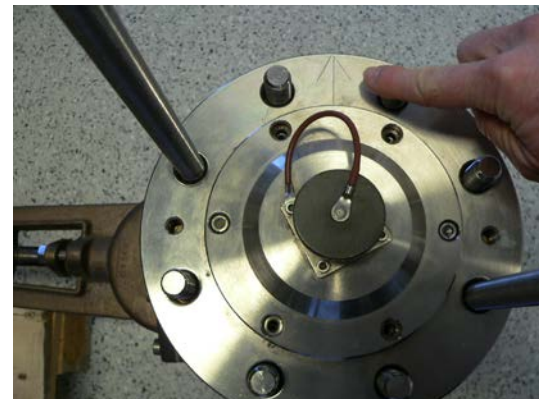
Remedy method 1:

The first batch of the new sensor 540kHz DL850S-SB was manufactured with forward arrow pointing 180 deg wrong.

Mount the whole transducer rotated 180 degrees.

(Forward arrow pointing aft)

Make sure a note is written on a sticker on the sensor in case the sensor is later lifted for inspection or cleaning.
