Technical bulletin

SB-100-SB Sea valves

Products: SB-100-SB, SB-100-SA, DB-100-SB and DB-100-SA
100mm Sea valves

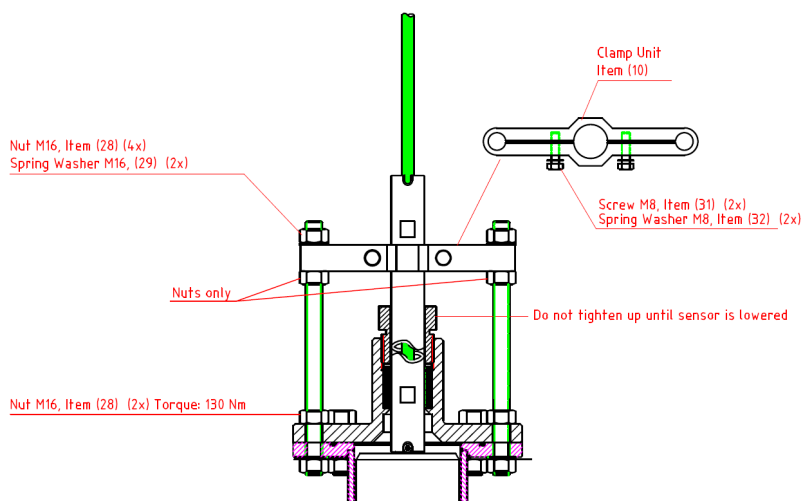
Issue: A number of Sea valves have been reported the two threaded holes in the intermediate element for installing 2 x thread bolts are not straight.
This can result in difficulties in entering the Clamping unit onto the bolts.

Do not use high force Bending the bolts to install the Clamping unit.
The threaded bolts can be mounted onto any of the 6 unthreaded holes.
Remember 4 x Nuts M16 and 2 x Spring washer M16 on each bolt.

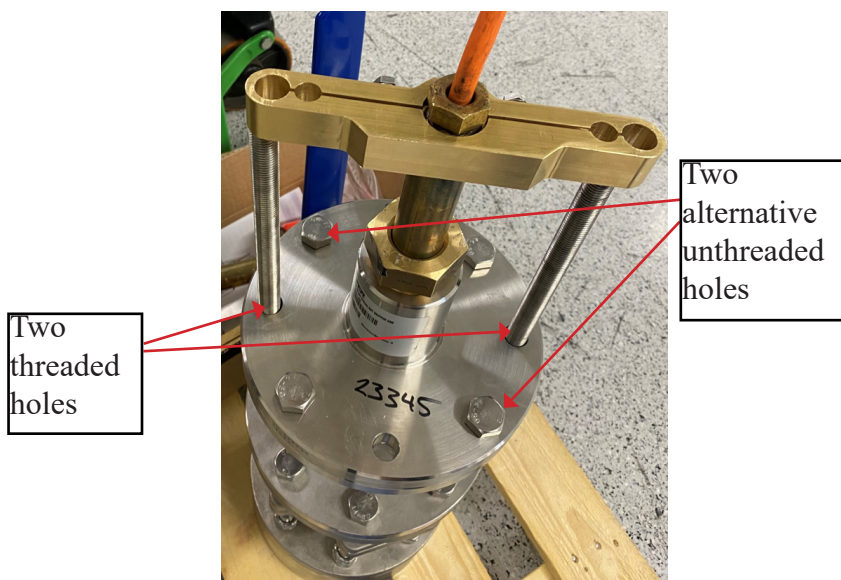
A number of sea valves are produced without threads in the “two threaded holes”.

This to enable easy installation and movement of the clamping unit.

The threaded bolts can then be mounted onto any of the unthreaded holes.

Remember 4 x Nuts M16 and 2 x Spring washer M16 on each bolt.
