Service instruction for EML224 Graphic systems with JB60N (Not N2 or CD) Electronic units.

19.2.09

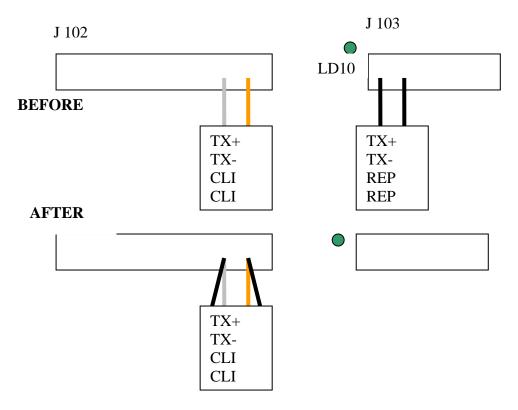
This unit has a diode LD 100 which indicates communication transmission, This loads the signal, weakening it over longer cables.

Symptoms. Communications stops from the sensor. But LEDS are lighting and power supply to sensor (J102 p 5 & 6 are ok >22V)

Solution. Bypass the LED by connection the J102 TX+ CLI and TX- CLI (white/orange or yellow/orange) to J103 TX+ REP and TX- REP (the Communication cable to the bridge unit).

SKIPPER Electronics have seen that this failure can occur after some time so we recomend all units to be wired in this way as a service task, or when retrofitting.
