SDB IR300 02 Insulation too low

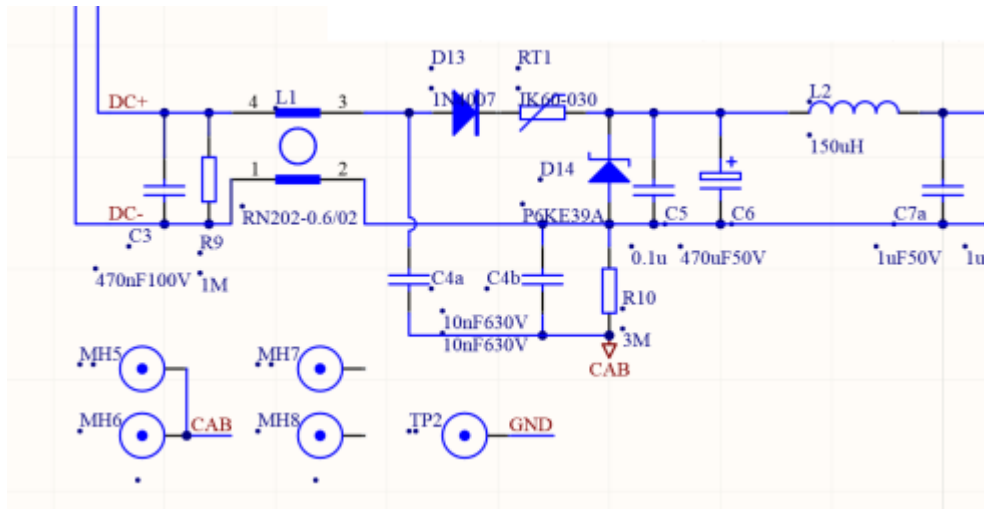
The IR 300 repeater has too low insulation between -24VDC and the ground.

This is caused by resistor R10 and applies to HW version < 1.8

The low insulation problem can be solved by cutting away resistor R10.

- 1) Loosen the 8 screws/washers holding the backplate of the IR300
- 2) Take care when lifting the backplate and observe J1
- 3) Locate **R10** on the IR300&301PWR PCB as shown on Fig. 1 and cut away
- 4) Assemble back in reversed order making sure J1 is in place
