## 1 Configuration of the system with software 1.0.11 or greater

## 2 Further Software upgrades of the system:

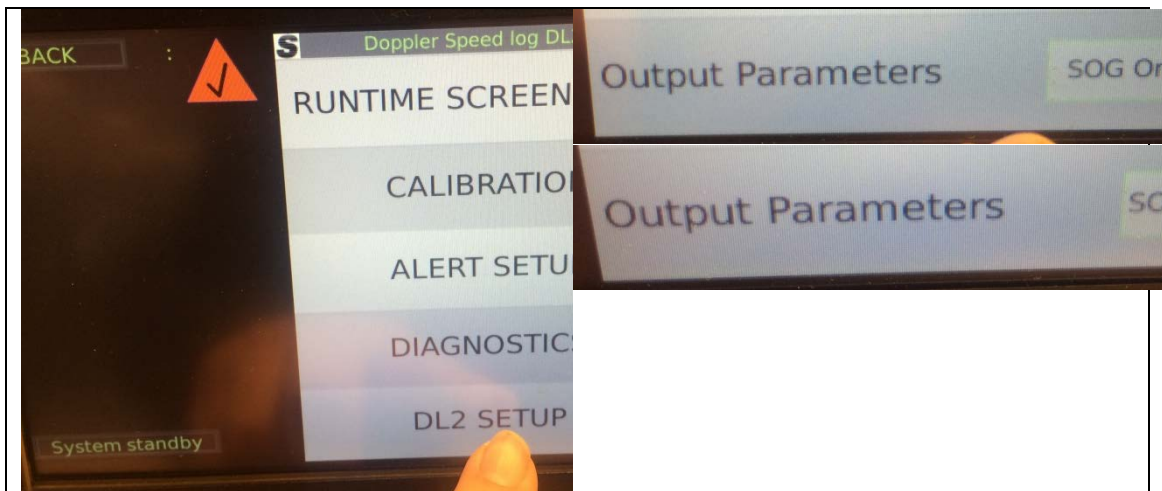
- Check cabling is correct such that Data comes from DL1 (middle pcb in JB 70D21-SA unit) for STW and from DL2 (lower pcb) for the SOG. Alarm should also be from these pcbs
- Ensure the software on the DL2 units is 1.0.11 or higher (go to Config JB70 and config CU-M001 in the menus on the 9" display).
- In menu DL2 setup , there is a button labelled 'SOG only or SOG+STW' ensure this is on 'SOG only' ( you may have to enter a configuration password 'service' to change this.)

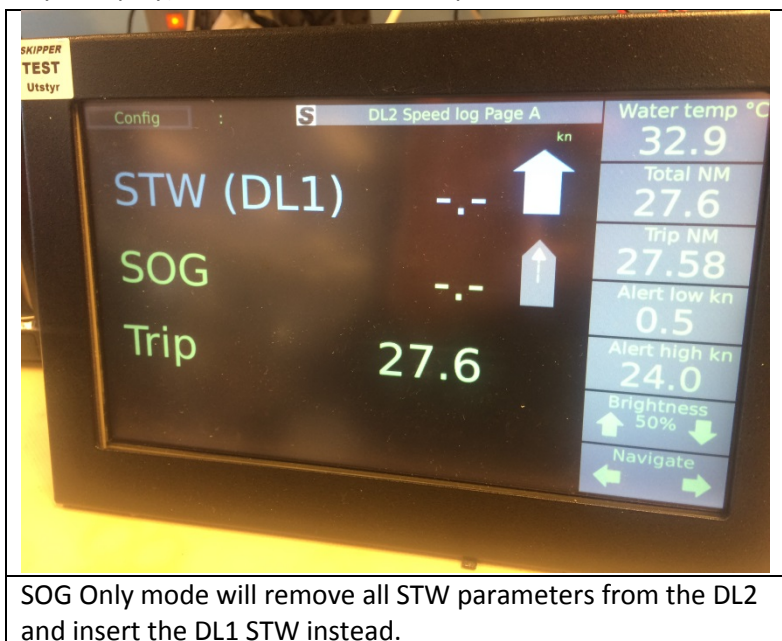
This will change the screen setup to show STW from the DL1 unit (The same as the Repeater style display) and SOG from the DL2 part.

SOG Only mode will remove all STW parameters from the DL2 and insert the DL1 STW instead.

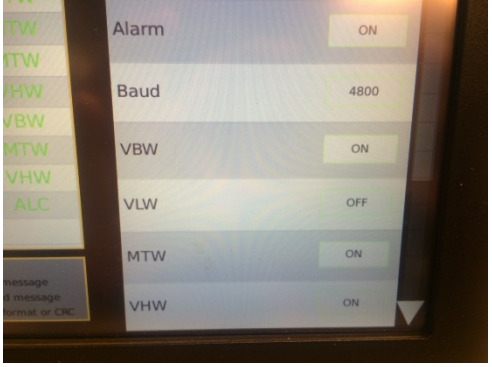
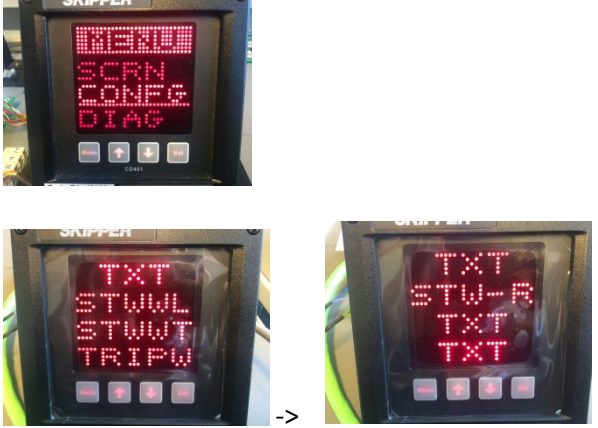
<p style="text-align: center;">Original                      -&gt;                      After change</p>

On DL2 screen in Communications, turn on VHW for DL1 STW speed	On The Compact multi repeater change CONFIG 1 from STWL to STW-R

Enter menus, config, on Screen 1 change STW-L,STW-T to STW-R, TXT.

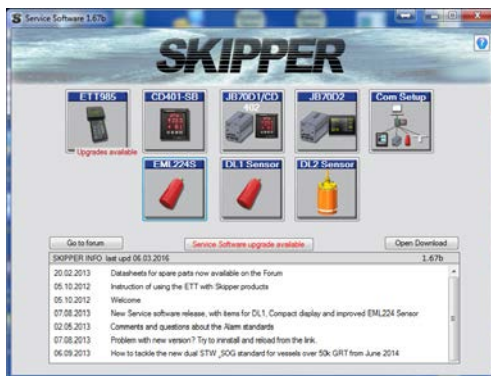
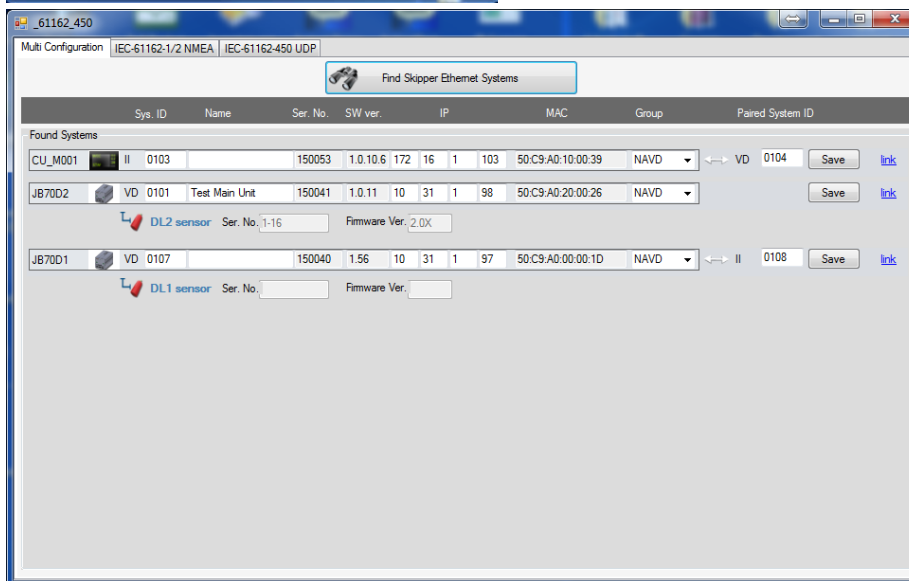
Connect your open this software and open the 'Com setup' tab. Press 'Find Skipper Ethernet Systems'

You should see the connected systems and the sensors connected to them. If you do not see this, but are connected. Check your antivirus settings, you may need to temporarily disable.

To upgrade a software or firmware you will need to ensure your system is in the same IP domain as the DL21. In the case above you can see that the systems are in 2 domains 10.31.1.98 and 172.16.1.103

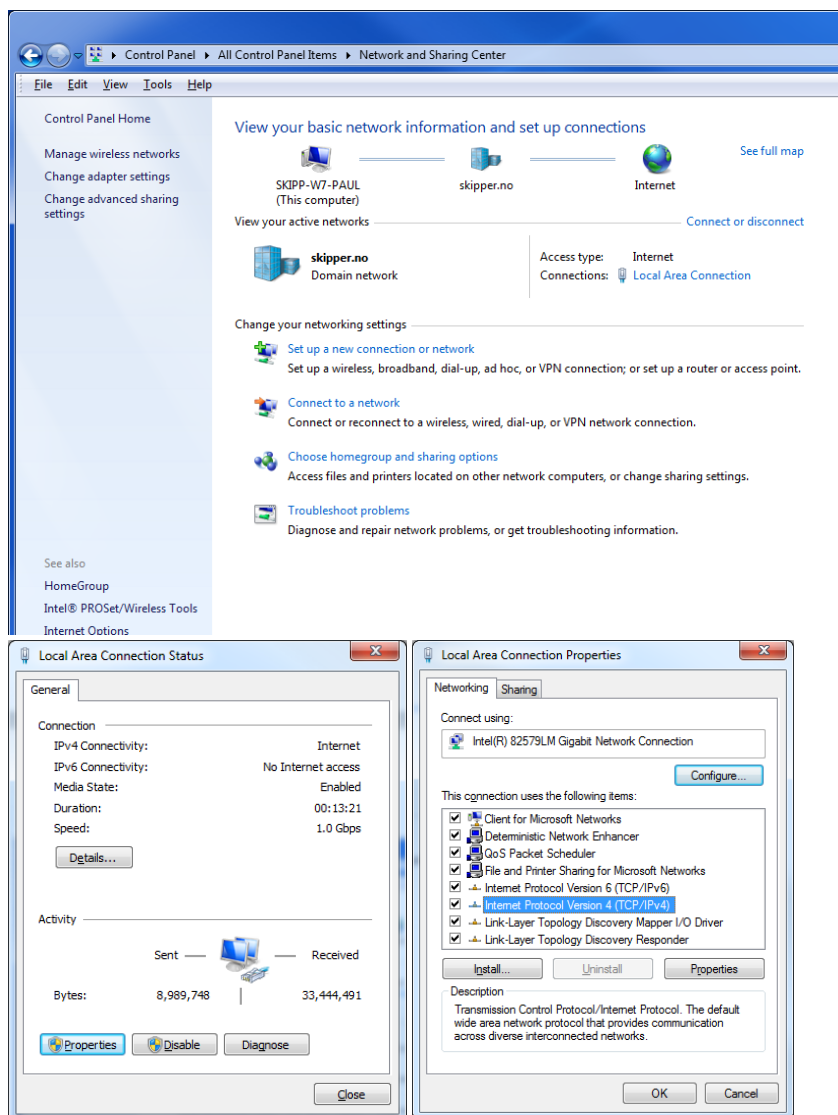
Unless you are using a router, To allow the systems to talk using TCP/IP V4 protocol one or the other will have to be changed. And the PC must be set to static. Go to 'network and sharing centre' in 'control panel'

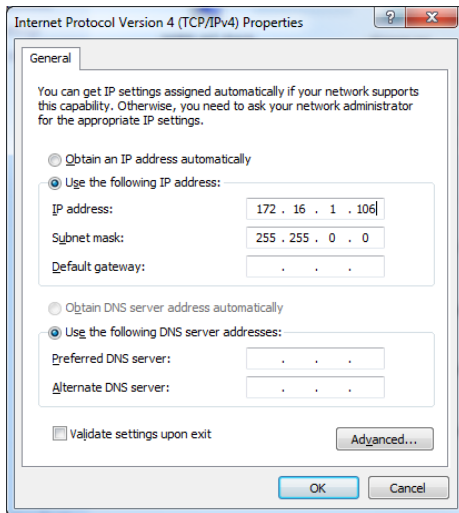
Setup the IP address and subnet mask as follows (or use the addresses similar to those used by the boxes if not the below.

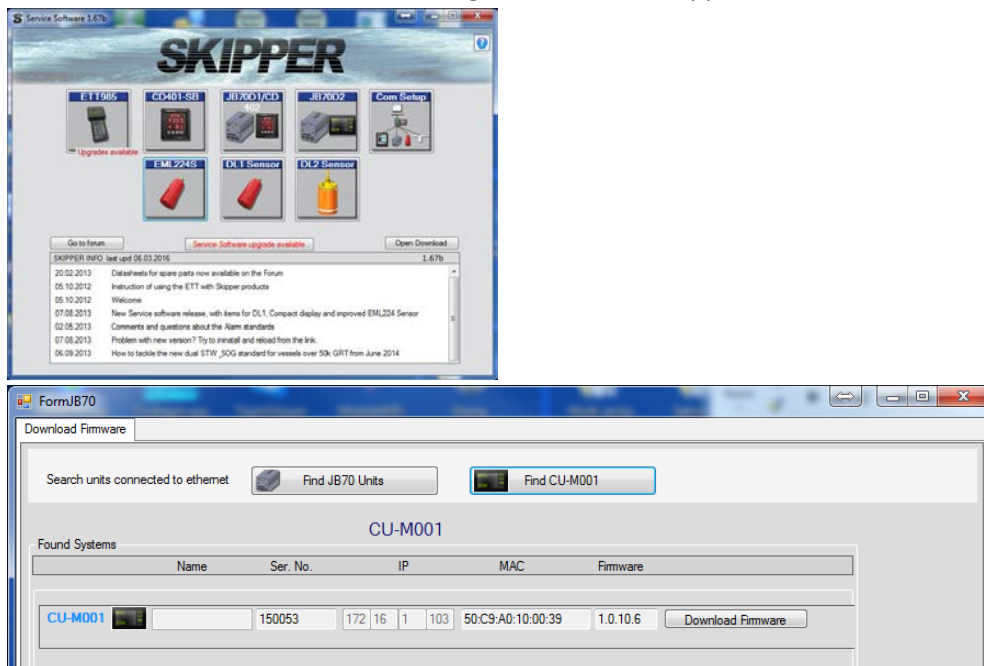
From the service software main menu go to the JB70D2 app, click on find CU-M001

Click on the 'Download Firmware' and search to the latest software. This can be found on the web at

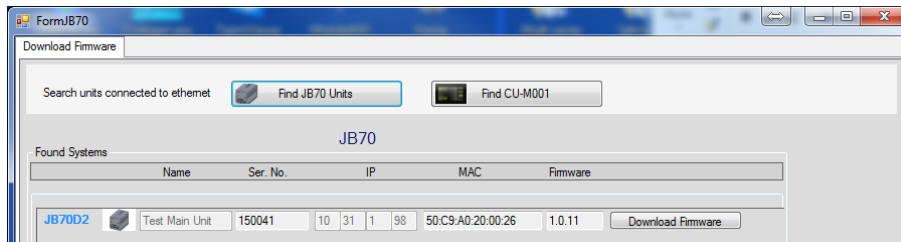
From the service software main menu go to the JB70D2 app, click on 'Find JB70 Units'

Click on the 'Download Firmware' and search to the latest software. This can be found on the web at

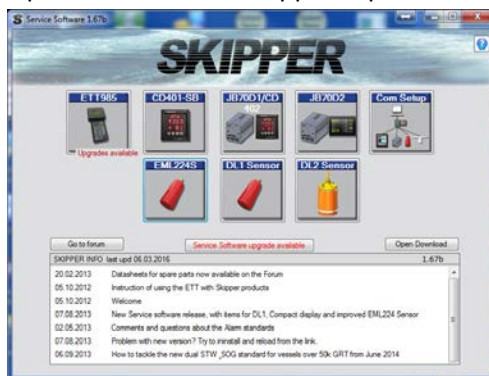
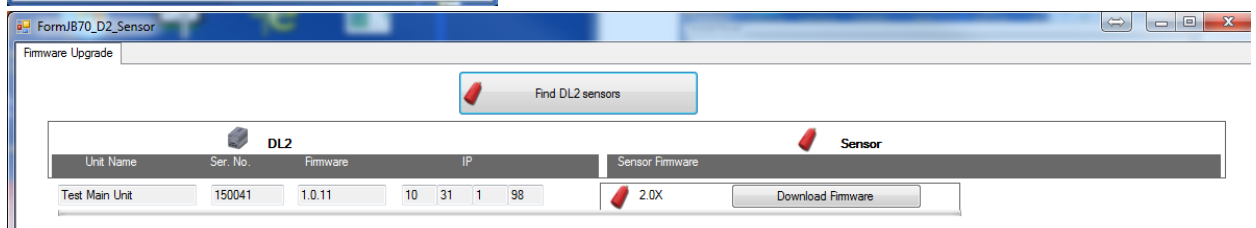
Open the DL2 sensor App and press find DL2 Sensors

Older sensors may show 2.0X, this is because they are not programmed to respond. New softwares in new sensors will respond with the software version (2.13, 2.14 etc.). If in this older case, ensure the sensor is connected and that values are currently being received from the sensor.

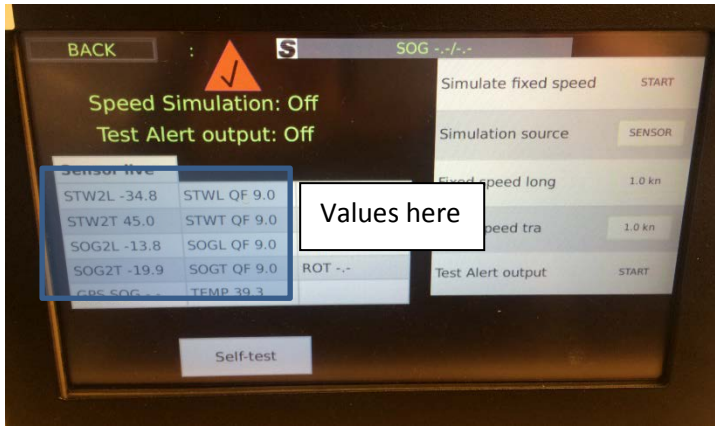
On graphic display go to Diagnostics and see values coming on the table to the left (Blue area)

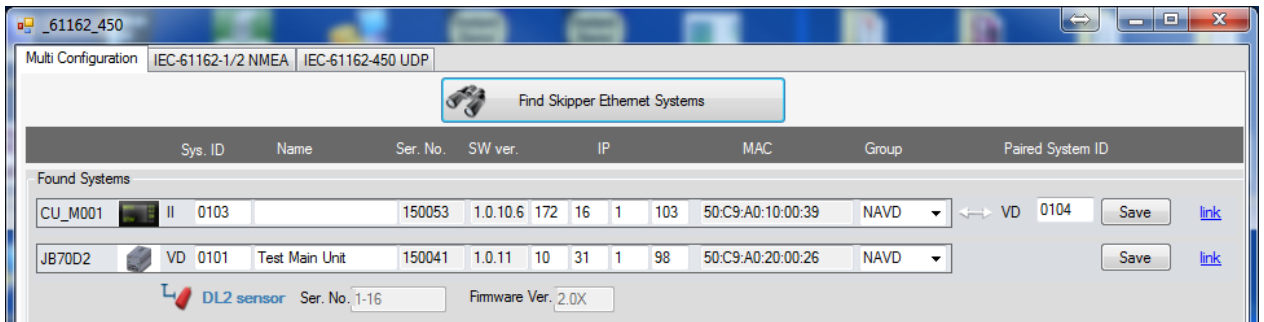
This firmware upgrade will take 2 to 3 minutes. After this process is finished. Restart the system and check using the com setup

You should now see the latest softwares in all units including the DL2 sensor.
