DL2 and DL21 Speed Log System

Reset of Total Trip Counter

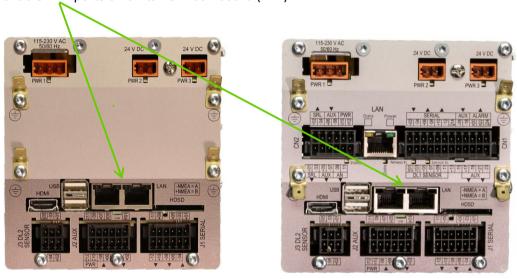
1) Locate the JB70D2/21 Electronic Unit and connect the ethernet cable to one of the two available LAN ports on units PC-M001 board (DL2).

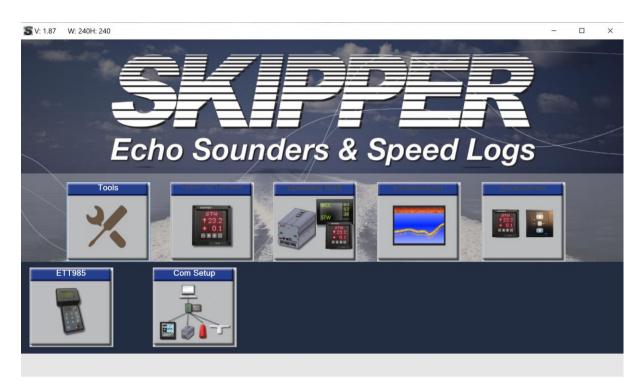
3) Start the Skipper Service Software and select <u>Tools > Com Setup</u>. Make sure the network selector is set to correct port.

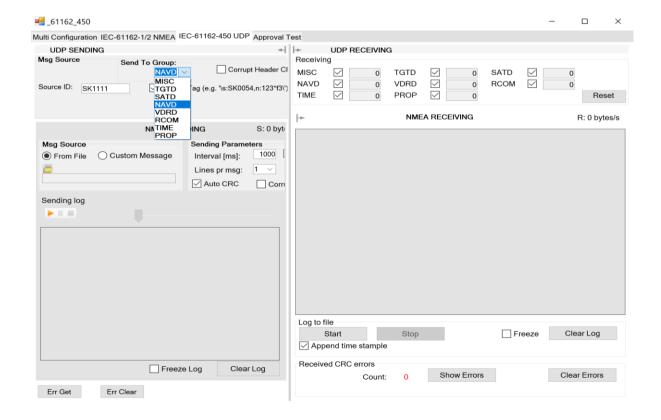
4) Select the IEC-61162-450 UDP Tab, make sure you change the Send To Group to NAVD

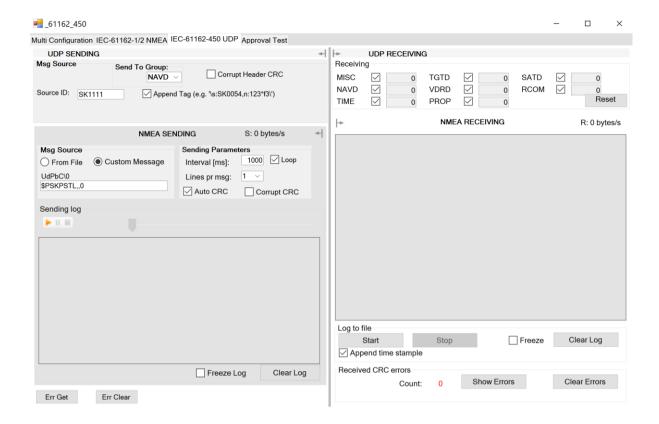
5) Select Msg Source - Custom Message
