## DL2 software hangups

DL2 units manufactured before January 2017 have some occasional freezing of software.

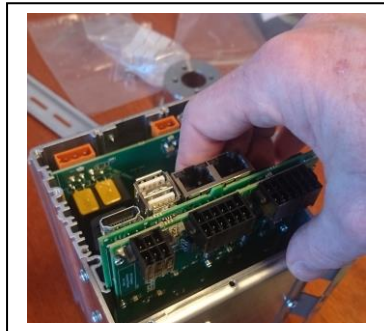
Remove all cables from JB70 box. Remove front plate. Torx T15 required.

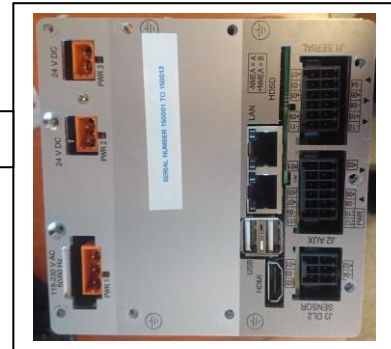
Locate and remove DL2 PCB

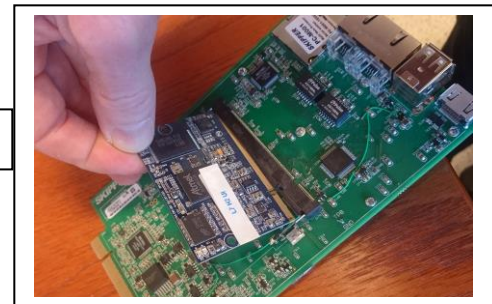
Locate the CPU unit on DL2 PCB. Remove from socket

On backside of CPU unit locate R28, a surface mounted resistor.
